PASCO COUNTY MYIP 2019

ATTACHMENT F – KEY VISTA SHORELINE STABILIZATION PROJECT

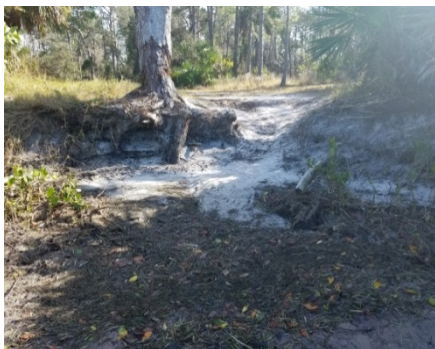
Figure 2- Soil Erosion

This will be accomplished through: the instillation of gabion baskets or an equivalent system that will promote mangrove growth, dredging of the channel leading to Sleepy Lagoon, and hardening the shoreline with the instillation of a concrete kayak launch. These enhancements will protect and restore these natural resources, specifically the soil and surrounding wetlands while allowing public access to the waterfront without damaging natural resources. The figures 2 – 4 demonstrate the current conditions of the shoreline of Rocky Creek.

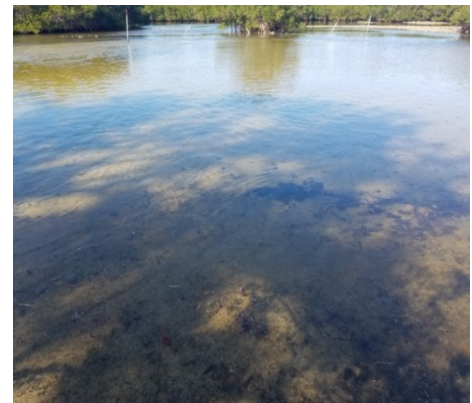
Figure 5- Proposed dredging location (low tide)

In addition to gabion baskets or an equivalent, dredging of approximately 600 feet of Rocky Creek will be required to restore natural hydrology to Sleepy Lagoon, thus promoting further habitat restoration. Currently, due to the eroding of the surrounding shoreline, the channel of Rocky Creek has undergone a significant amount of sedimentation. This has affected the hydrologic connectivity of the lagoon and the tides resulting in habitat degradation. A method of restoring this natural resource is to remove the accumulated sediments by dredging the affected area. “*The Corps of Engineers, Bureau of Reclamation, and their state counterparts have undertaken many **habitat restoration projects as part of maintenance dredging**... (Dr. Jon Kusher, Ph.D.)*.” Similar efforts, on a larger scale, have been undertaken in New York City by the New York City Department of Environmental Protection involving the dredging of Flushing Bay. “*The proposed project would not result in any long-term or significant adverse impacts to water quality... The proposed **project would likely improve water circulation and improve water quality*** (NYCDEP Flushing Bay Environmental Assessment Statement).” Once the sediment is removed and hydrologic connectivity is restored, the biodiversity of the area is likely to increase; “*The proposed project would **incrementally improve the benthic community, due to projected improved water quality and tidal circulation*** (NYCDEP Flushing Bay Environmental Assessment Statement).” Such results were observed in the Flushing Bay project in New York. “*Some species are coming back ... horseshoe crabs, turtles and birds we had **never seen before*** said Shrinivasan Sewgobind, the DEP’s project manager (Lisa L. Colangelo, 2018).”

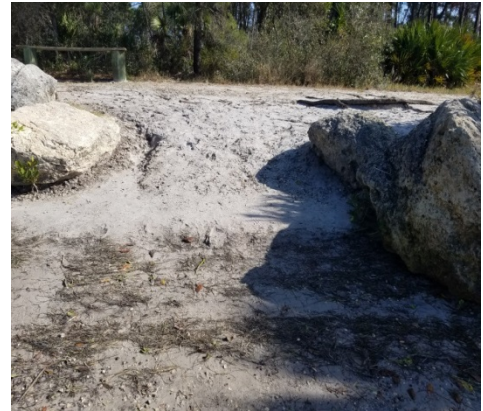
Figure 6- Future Location of Kayak Launch

The final method to protect the shoreline from further erosion and maintain the integrity of the surrounding habitats would be the hardening of the shoreline by installing a concrete kayak launch on the shoreline. This would give the public access to the water while still preserving natural resources. *“A properly designed and constructed structure [shore hardening] will protect the upland from wave attack and stop shore erosion* (National Academies Press, *Mitigation Shore Erosion along Sheltered Coasts*).”
